# FRAME YARD EXCAVATION REPORT 2013

*Rosabella Alvarez-Calderon Silva-Santisteban*  
*Garden Conservation Intern*  
*August 2013*

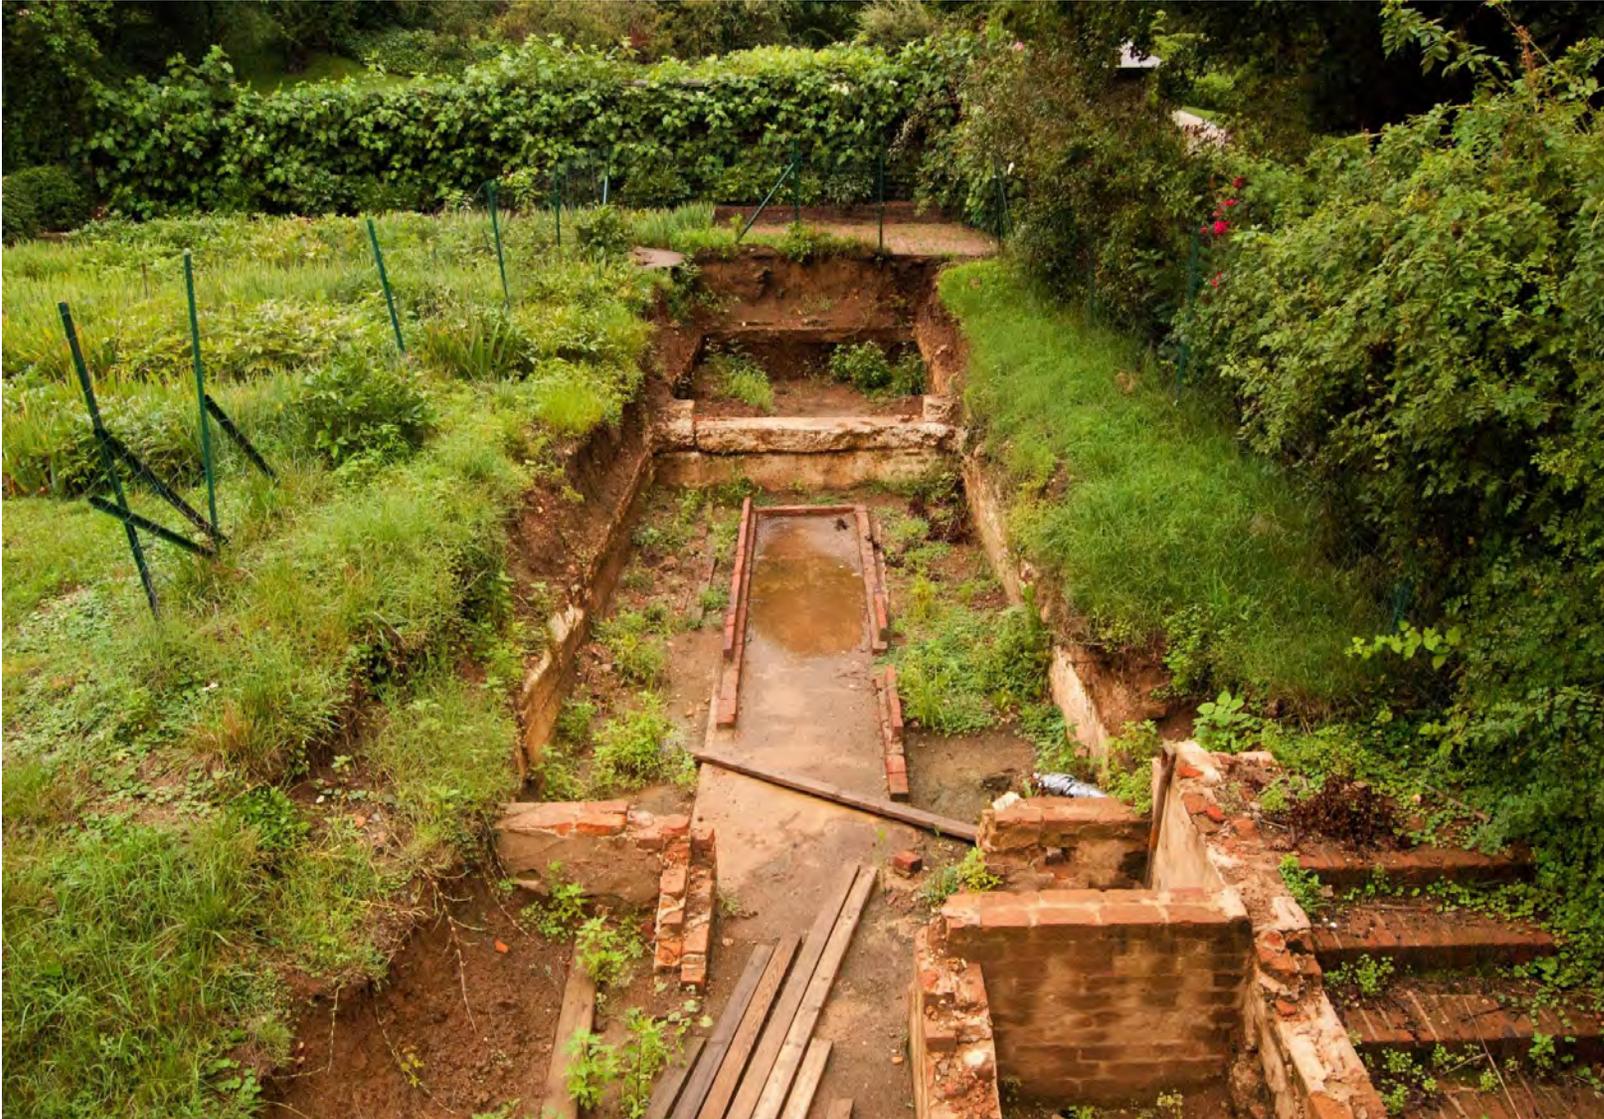
The pit house before starting the excavation, July 2013

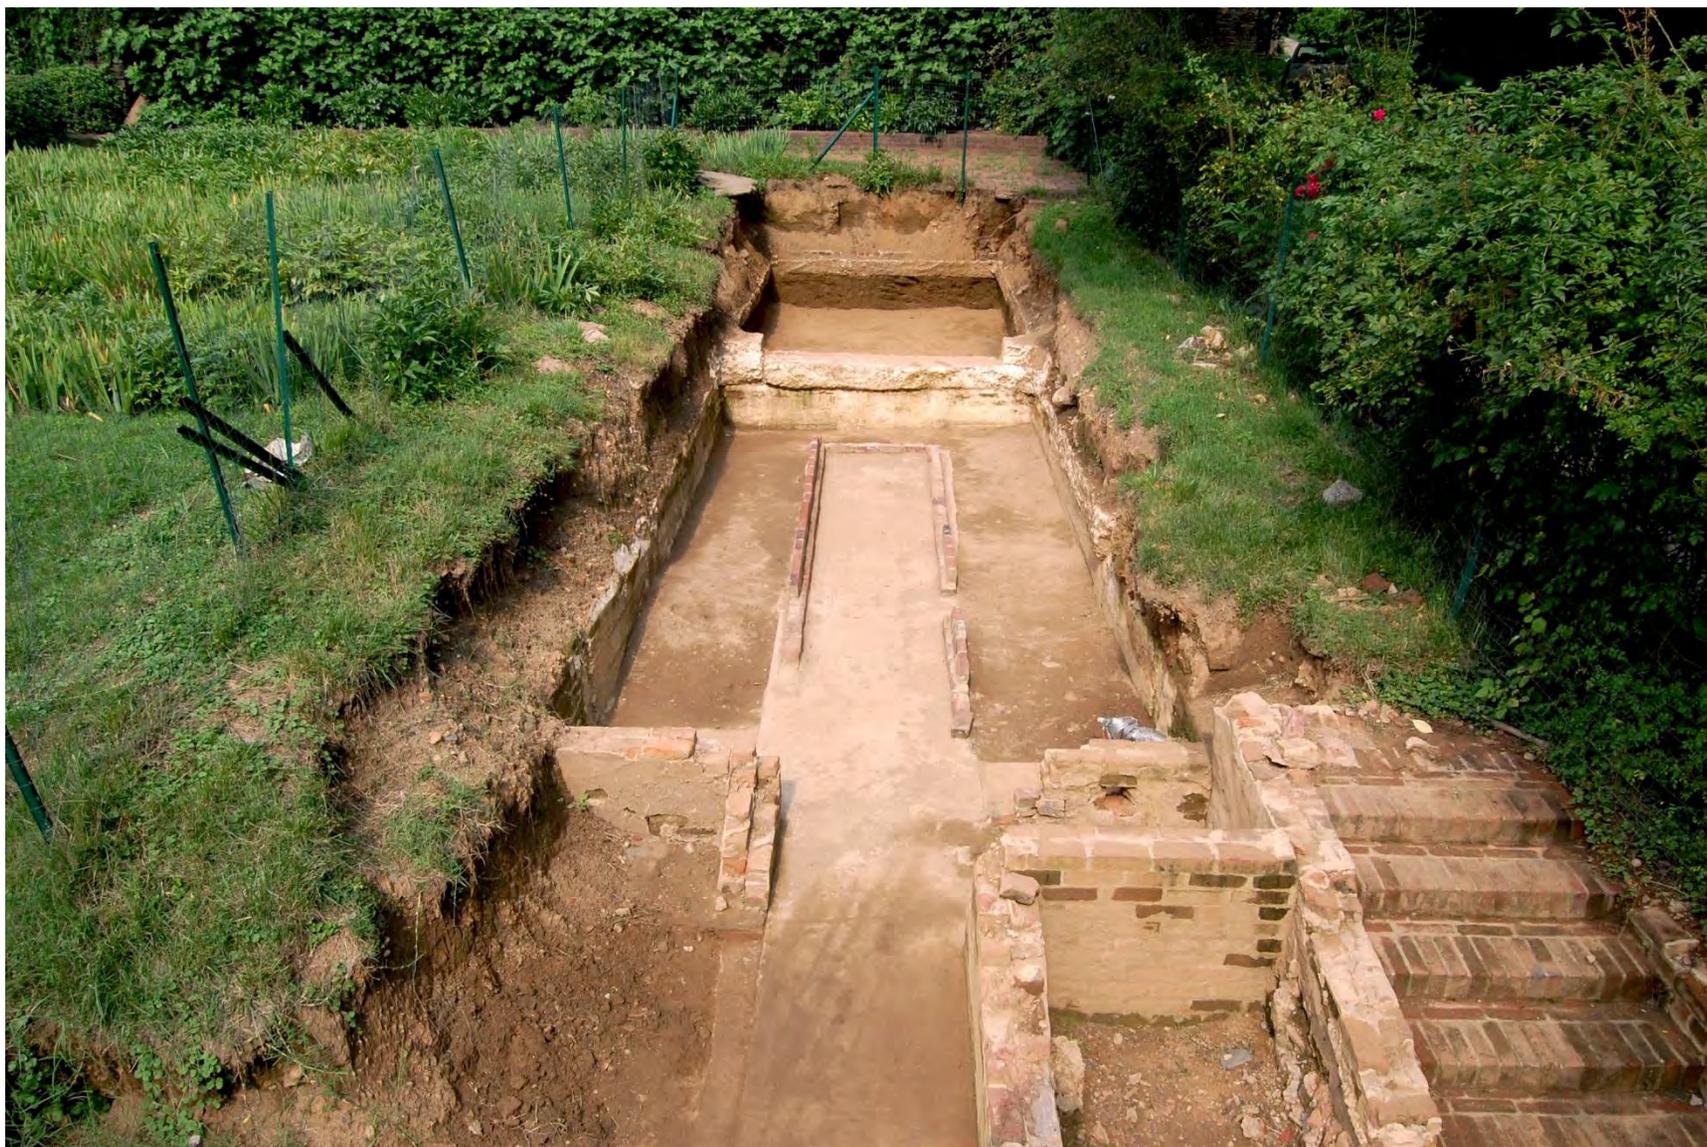
The pit house after clearing the weeds and trimming the grass around the area, July 2013.

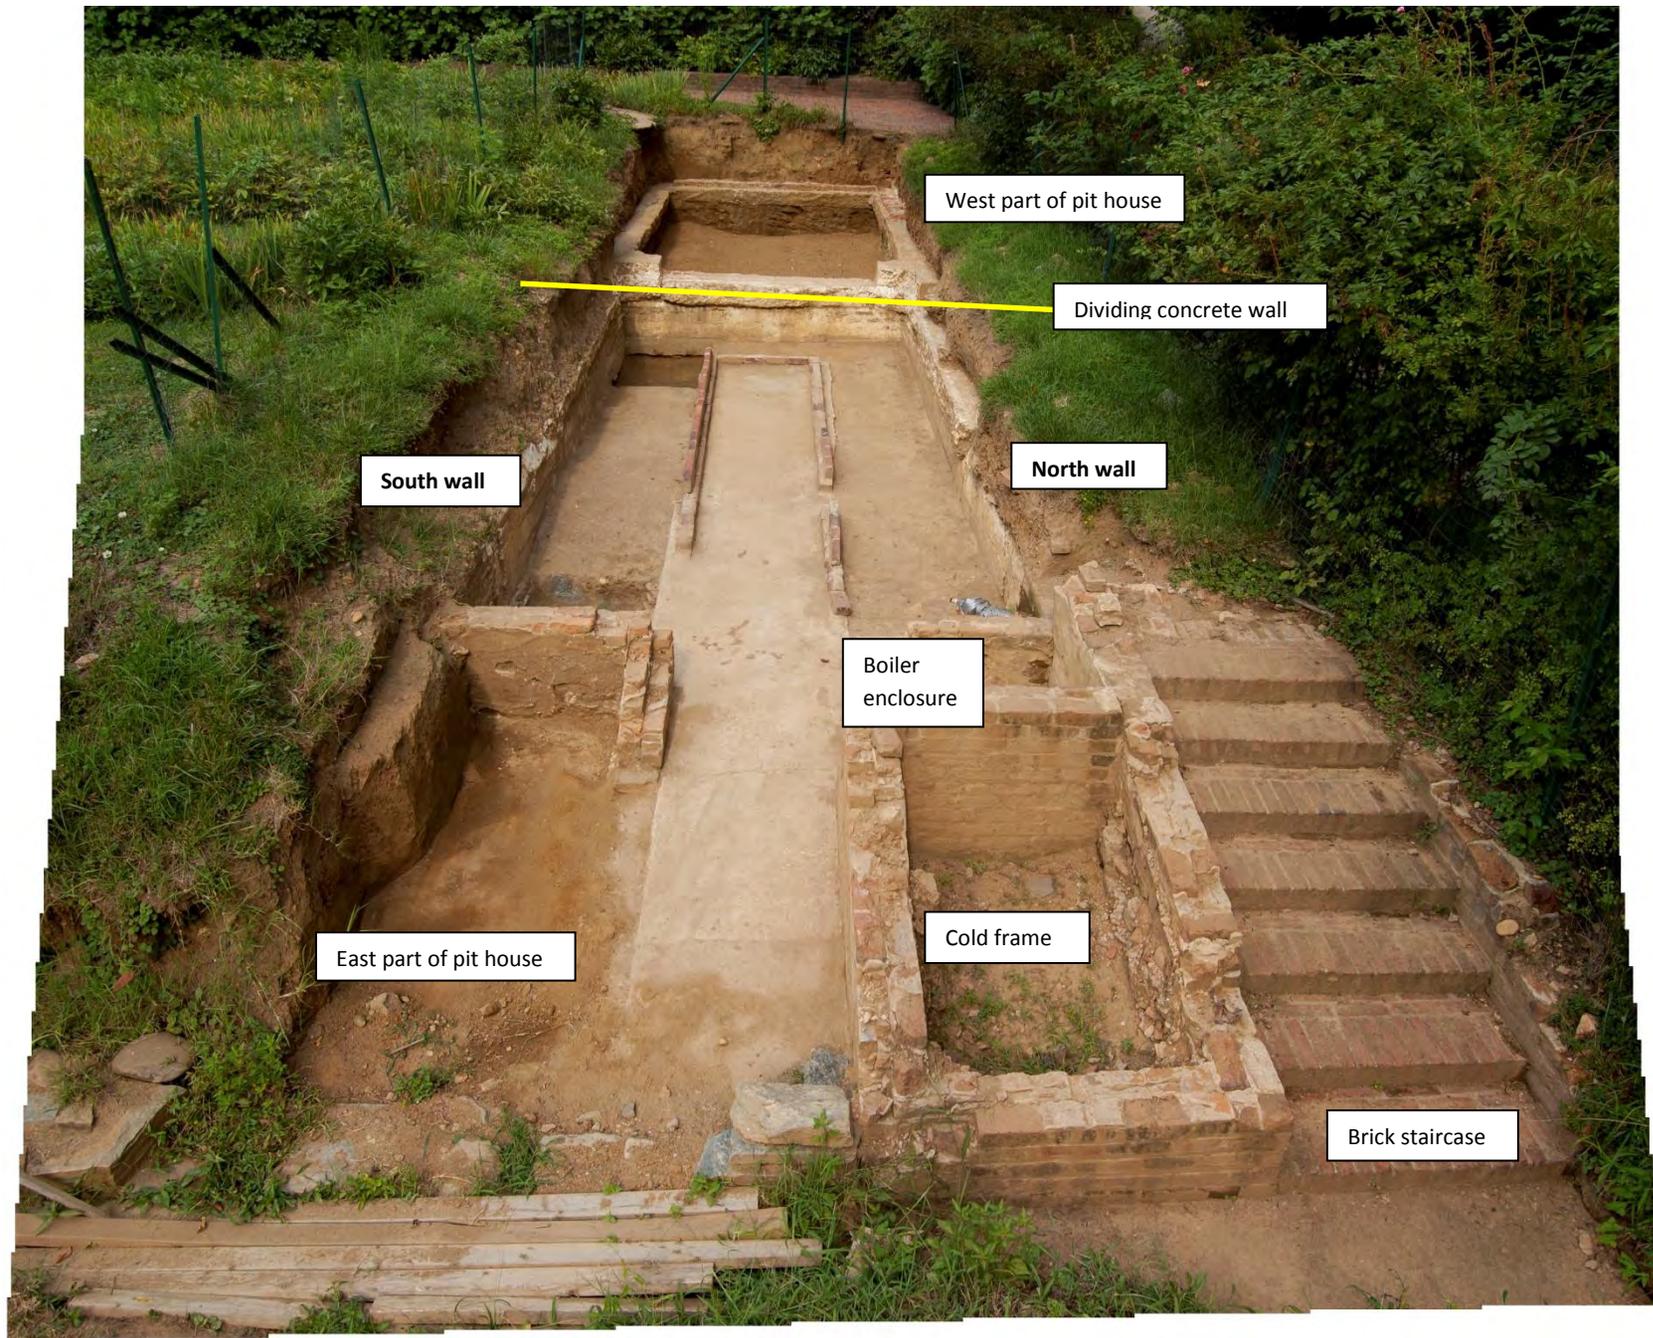
The pit house at the end of the excavation, August 2013

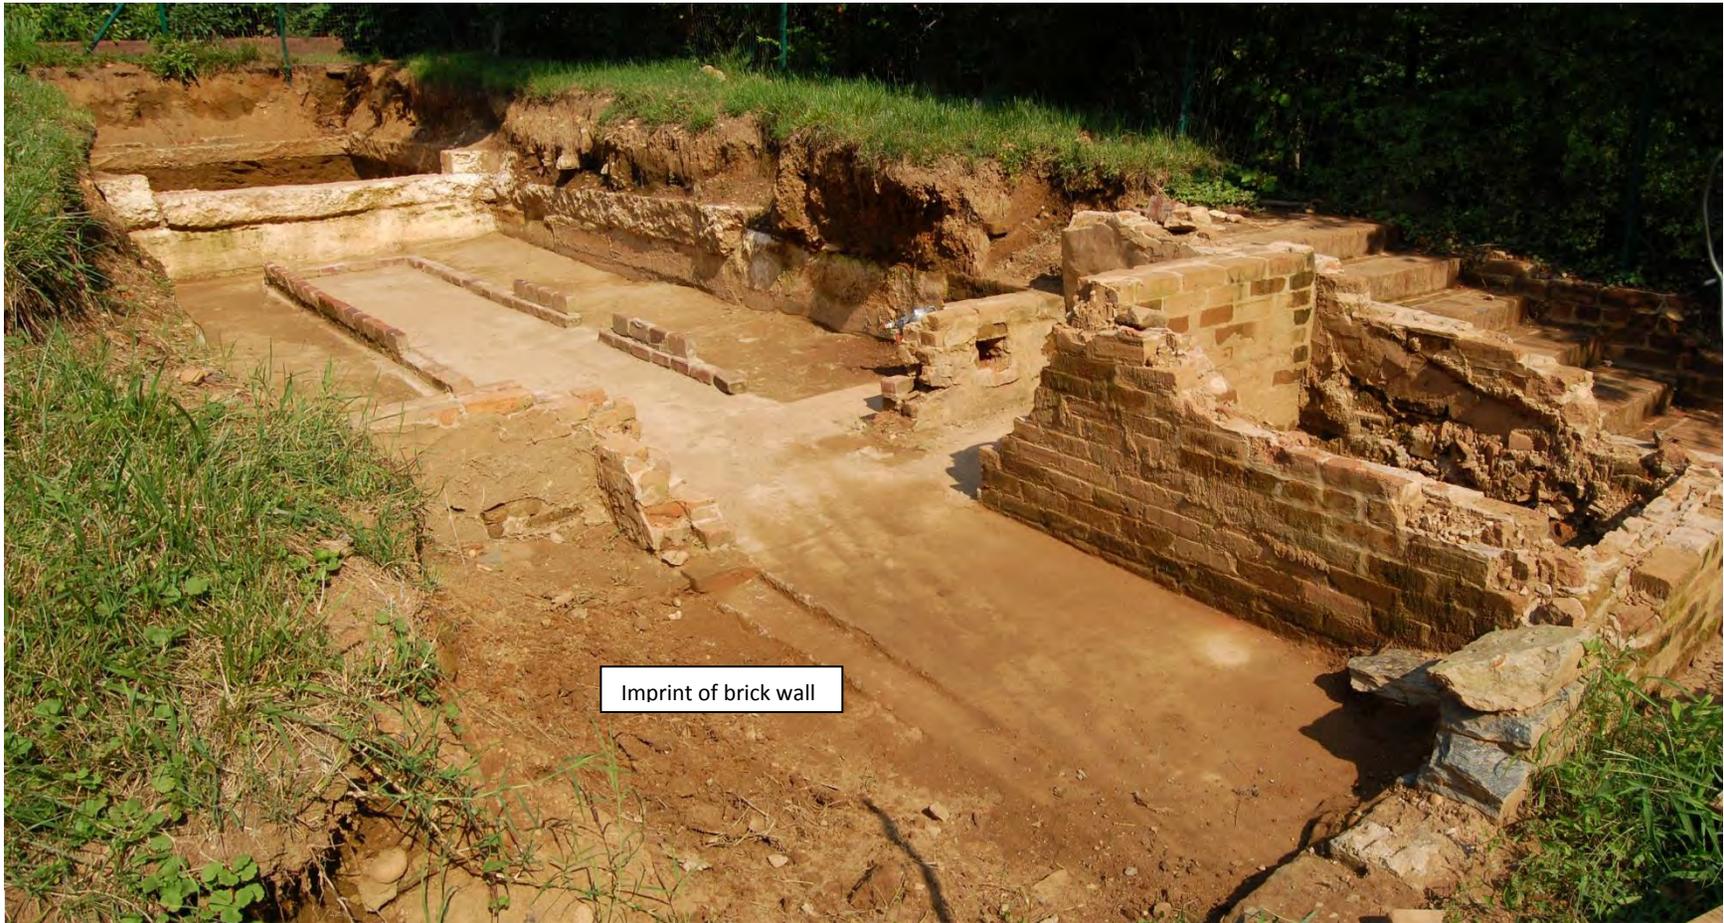
View of the east part of the pit house, showing the central concrete corridor, the boiler enclosure, the brick staircase, the boiler enclosure, and the entrance

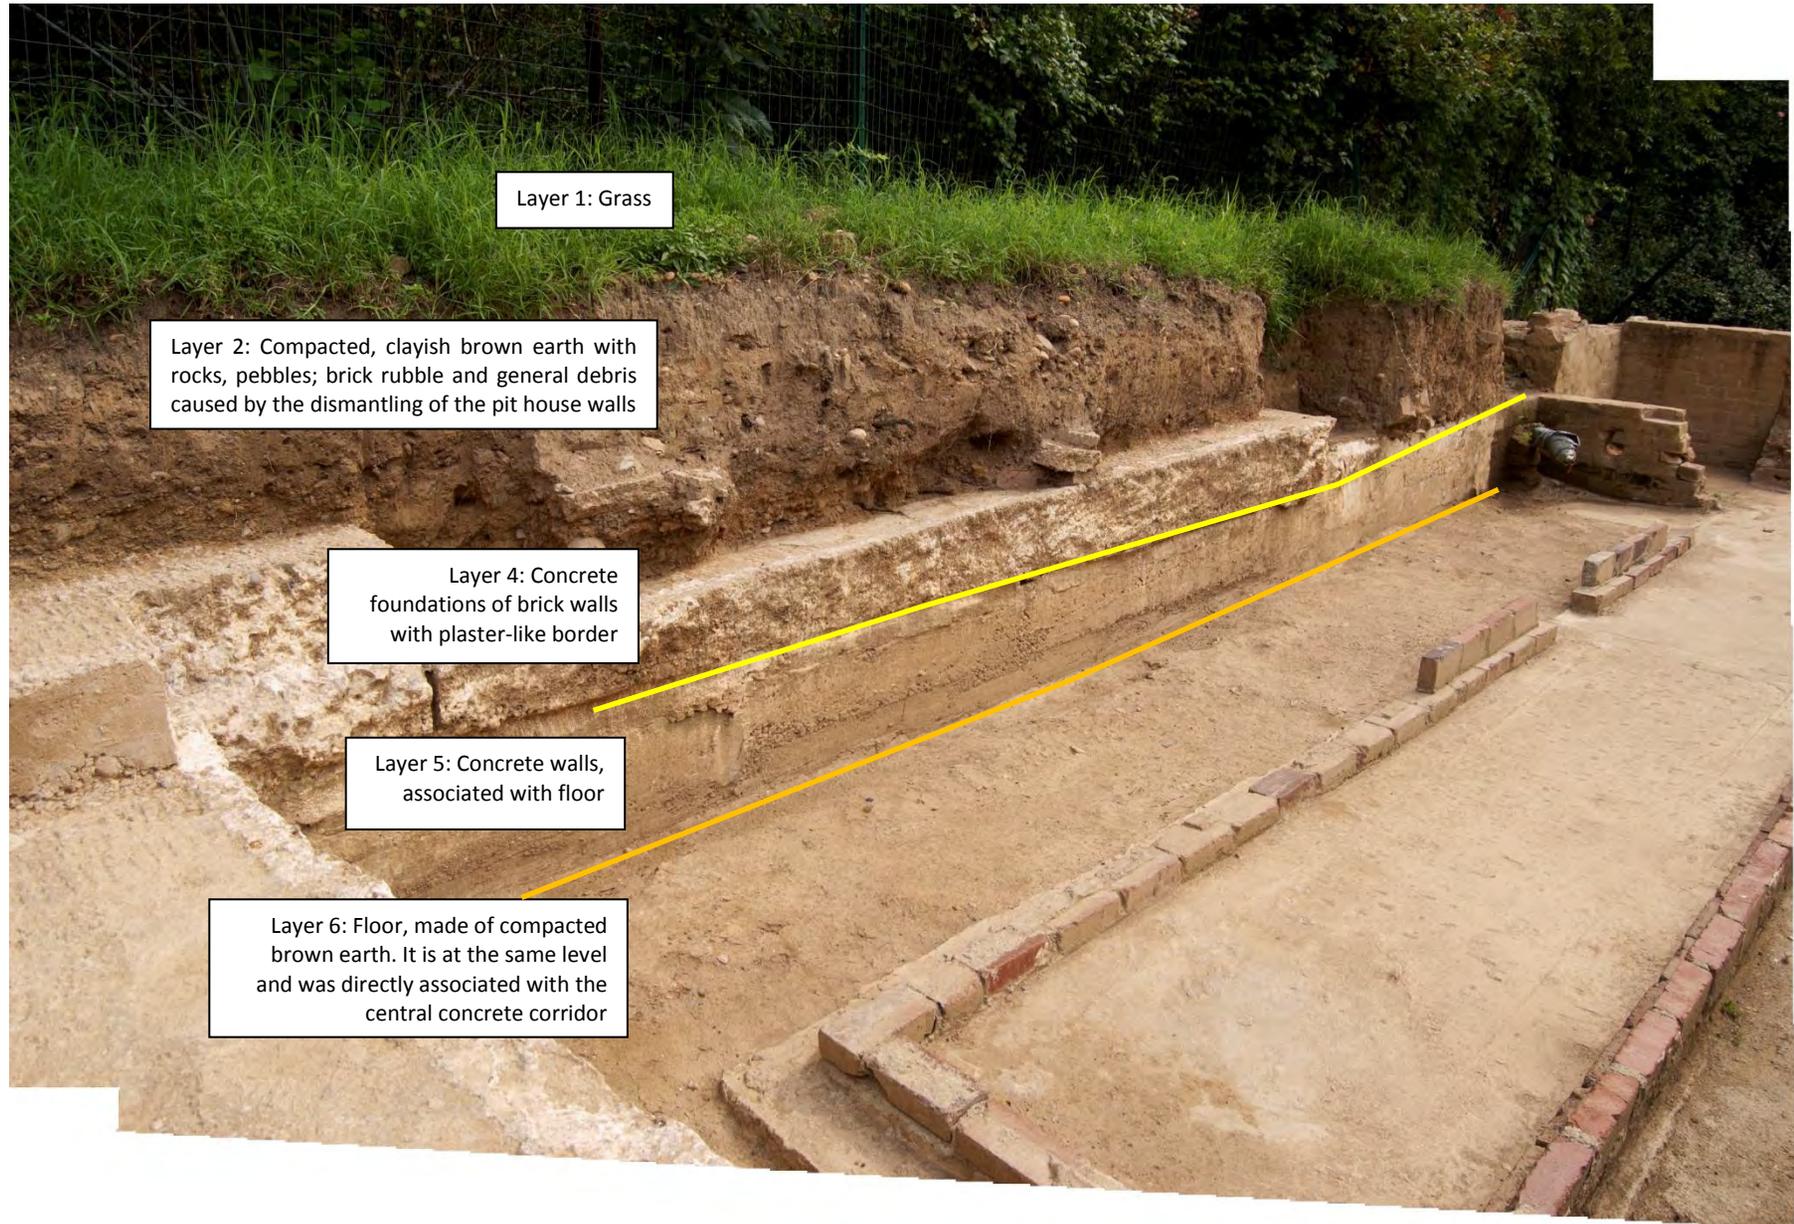
View of the eastern part of the pit house, north profile, showing the stratigraphy. Layers 1 and 2 would have been deposited and grown after the structure was dismantled, leveled and planted over with peonies. Layer 7, which only became visible through the excavations in units 1, 2 and 3, consists on very hard, compacted and rocky greenish-brown earth. This level, which extends under the concrete foundations of the structure, would have served as the base on which the pit house was built.

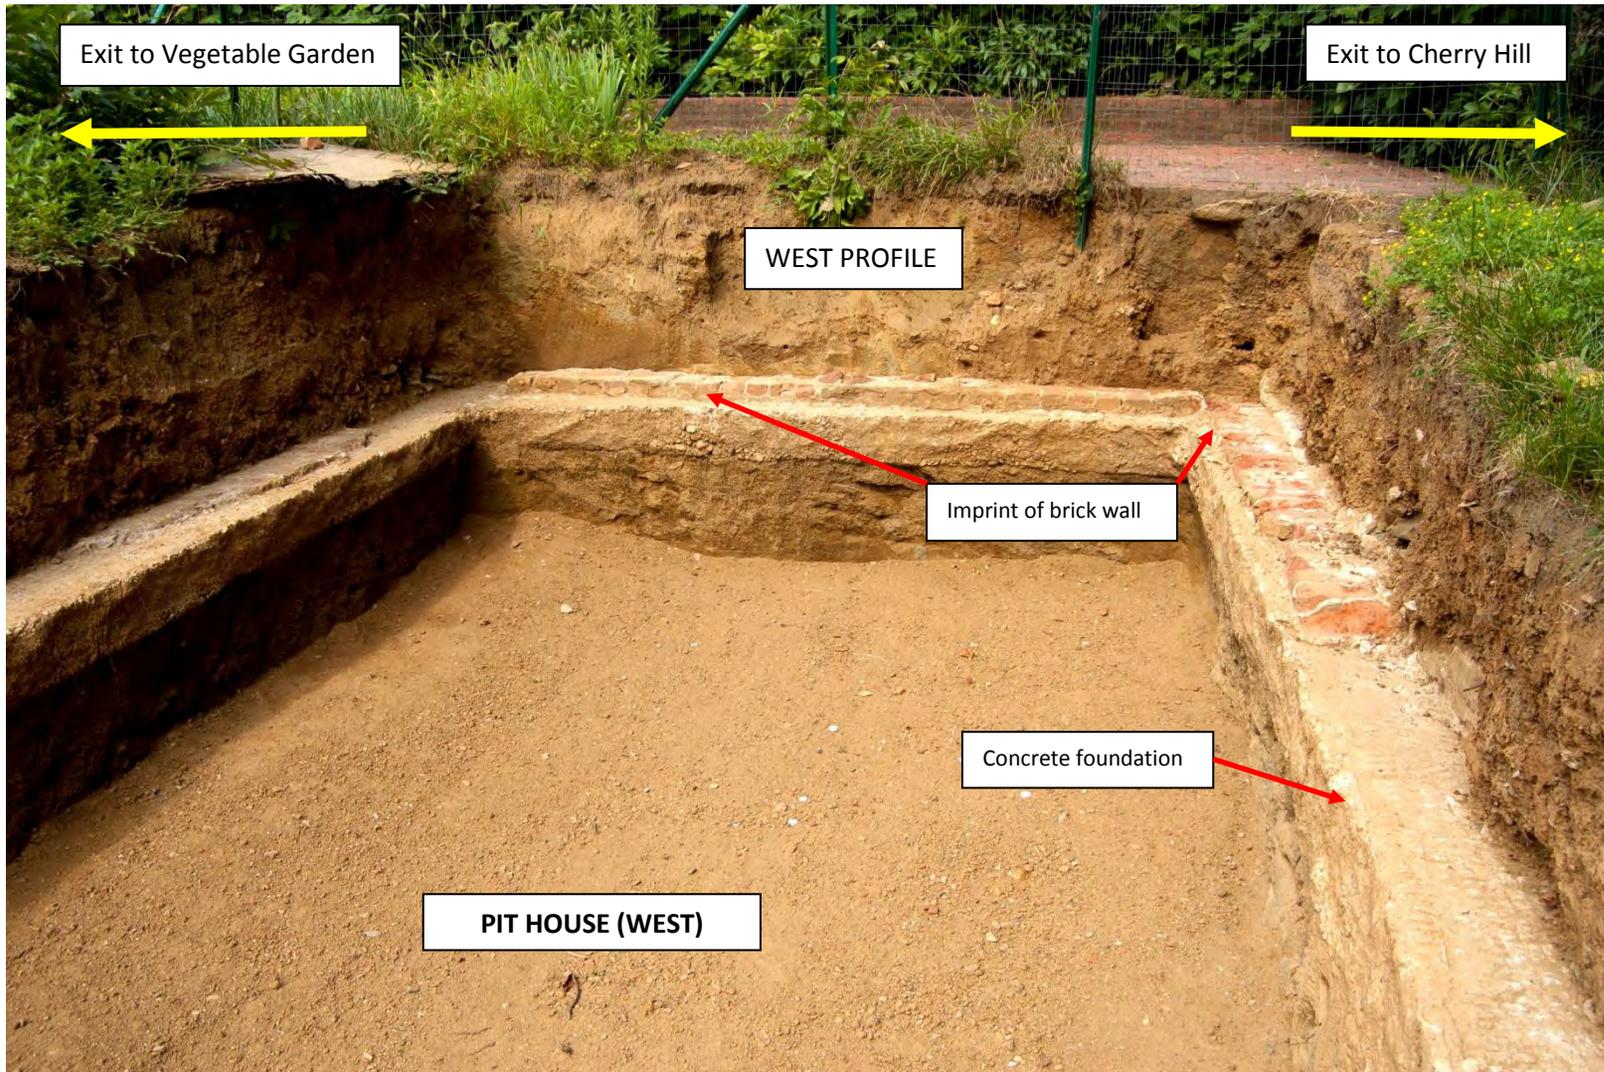
Pit house (west), view from the east. Detail of the concrete foundations and the imprint of the brick walls. The walls were at least two bricks tall, and the surface of the concrete shows imprints consistent that imply that bricks bricks and mortar were laid on top. Unlike the east part of the pit house, there is no clearly distinguished floor and it is possible this space might have been at a higher level.

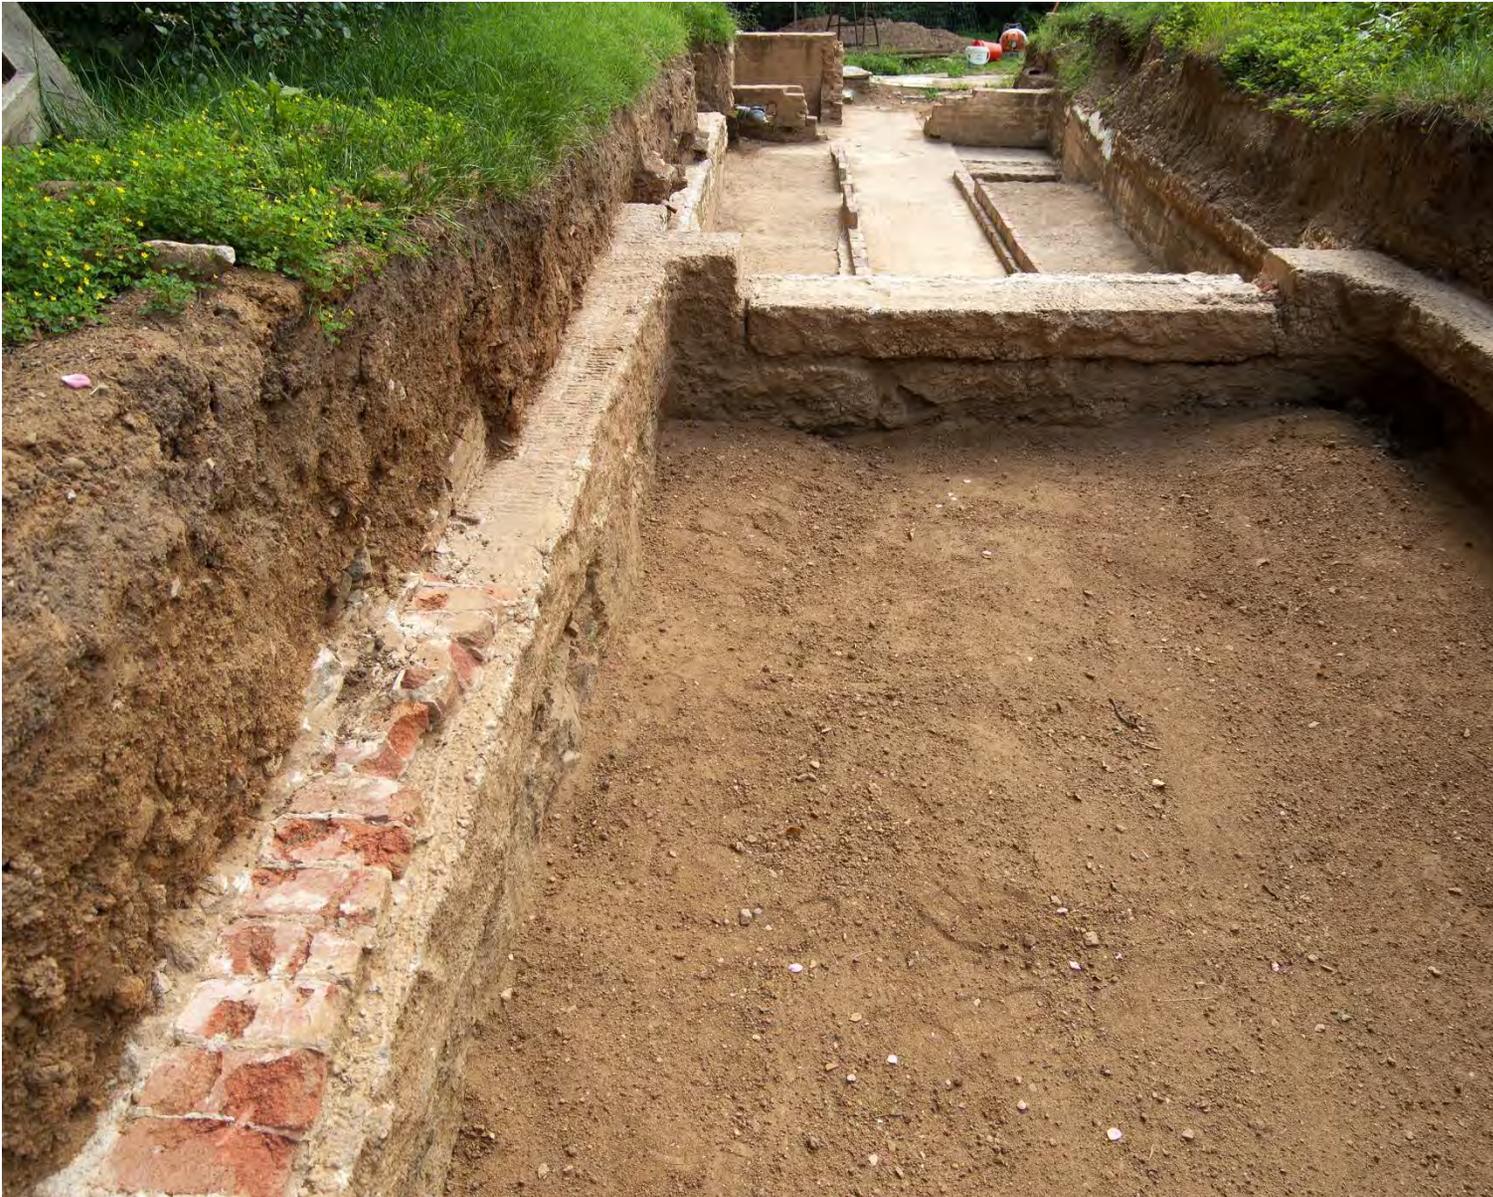
View of the pit house from the west, showing the east part (below), the west part (above), and the imprint of the brick wall with its concrete foundations (left)

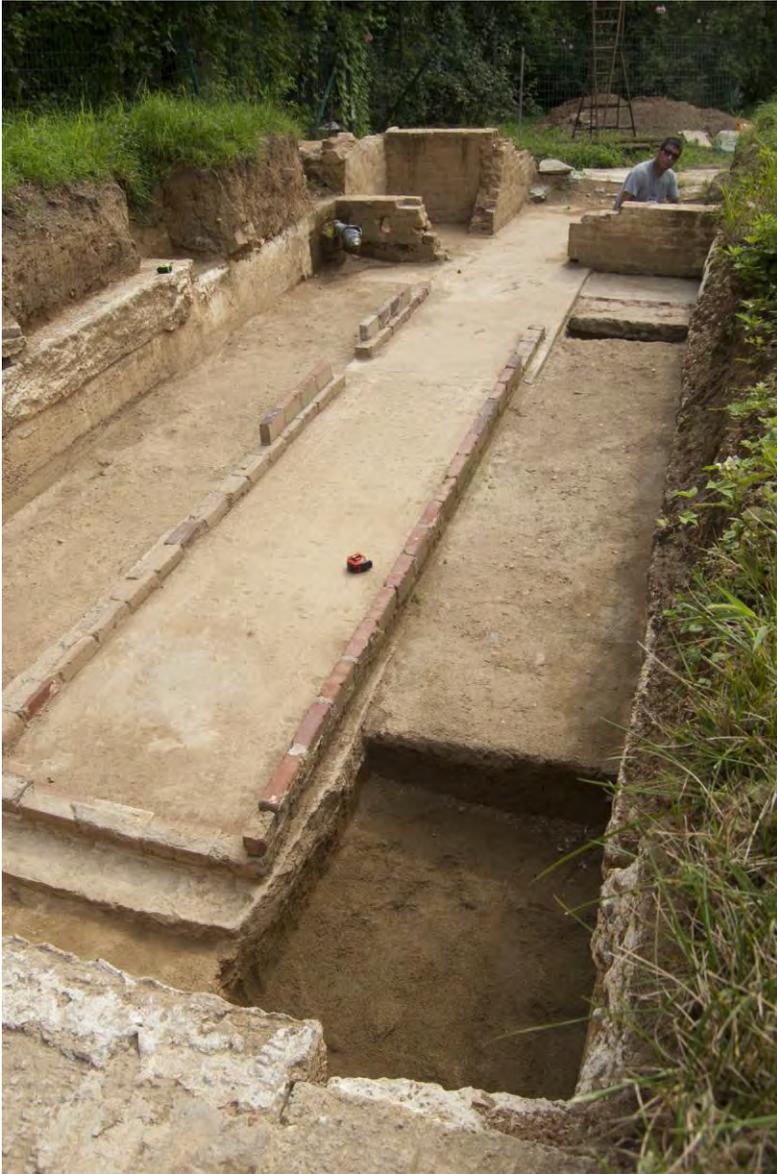
**Unit 1:** Located in the southwest corner of the east half of the pit house. This unit was excavated to establish the relationship between the walls and the centre concrete corridor.

Left: View of unit 1 from the east

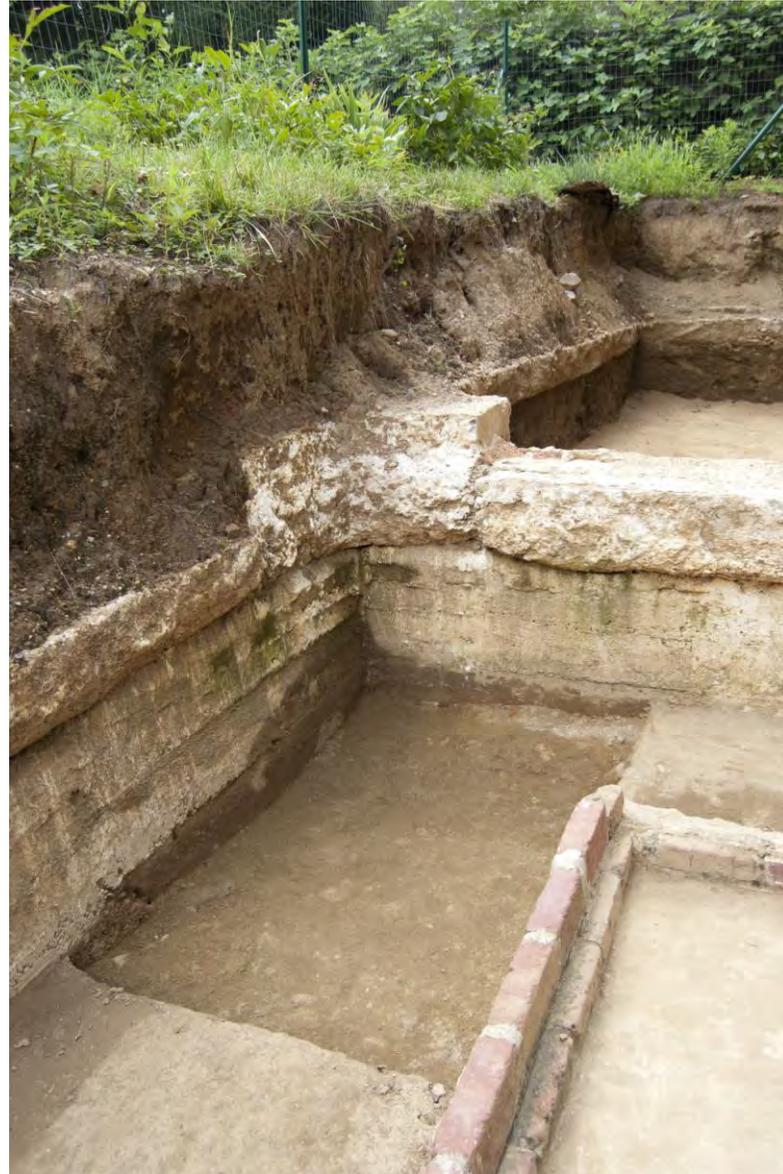
Right: View of unit 1 from the west

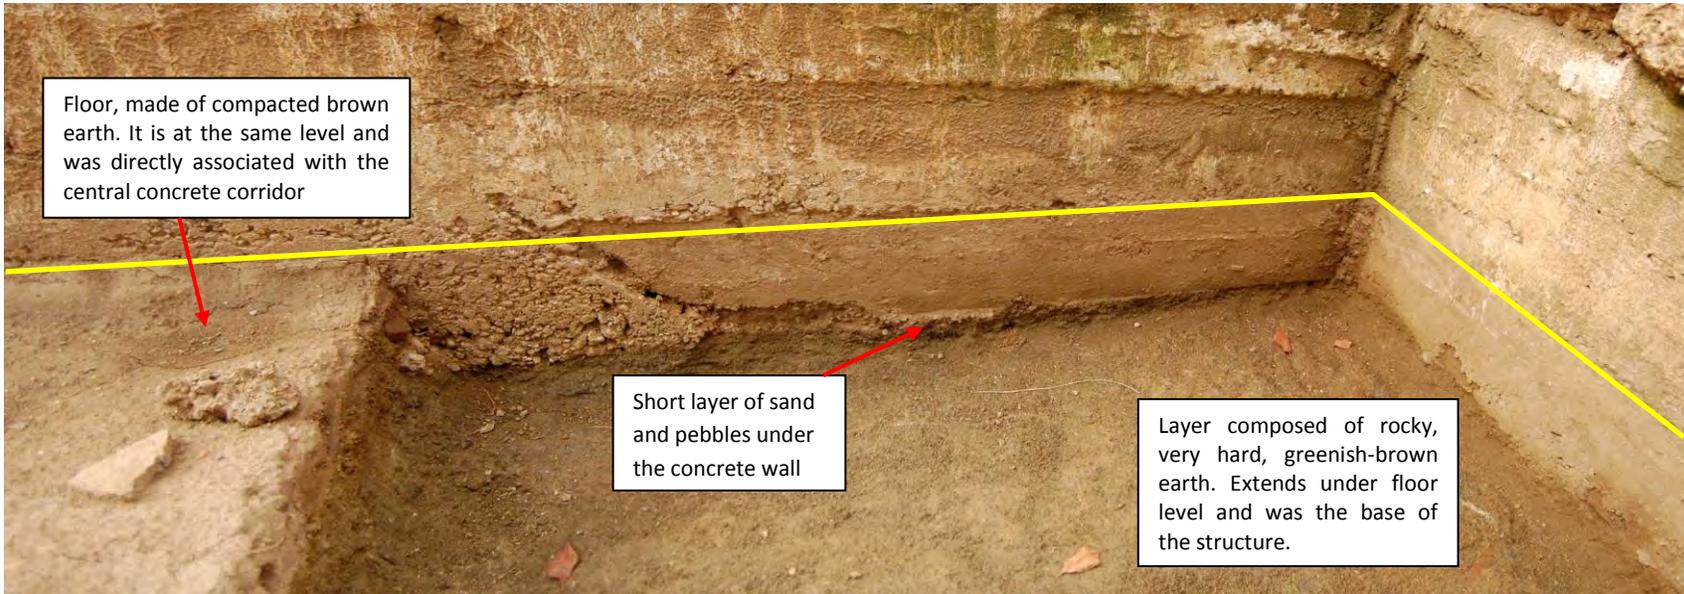
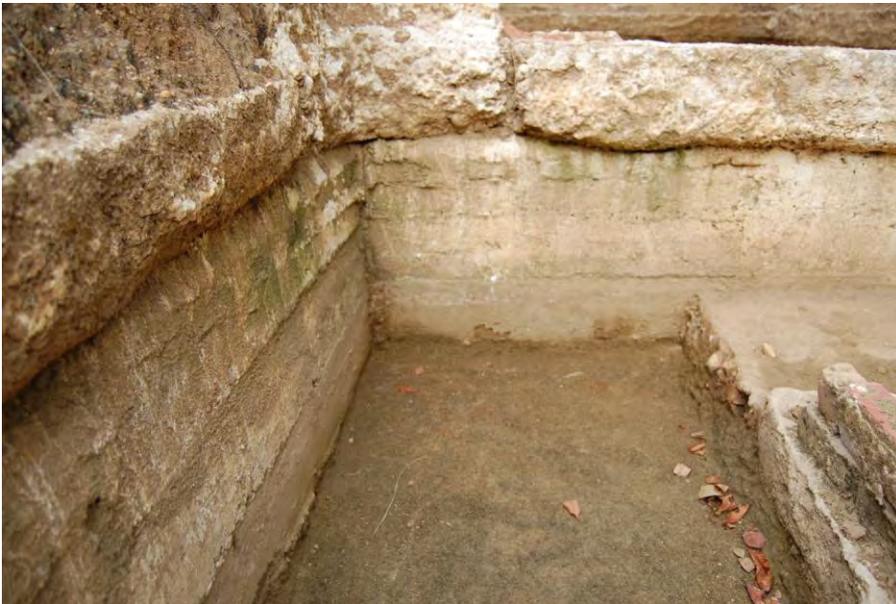
The first layer consisted on very hard, compacted, clayish brown soil that was approximately 8-10 inches thick. The topmost 2-3 inches of the surface were lighter in color due to exposure to the sun and elements.

The second layer consisted of very hard, compacted, rocky greenish-brown soil with mica. This layer extended under the concrete foundations of the south and west walls, and due to its hardness, it was very difficult to excavate using normal tools (shovels, picks and trowels). It was decided to end the excavation at this level, since it was apparent that this soil would have served as the base of the structure.

Under the south wall, between the first and second layer, there was a small layer of sand and small pebbles, which would have been part of the building materials of the wall.

Top: Detail of the excavated area of unit 1, showing the layers. View from the north

Bottom: Detail of the excavated area of unit 1, view from the east

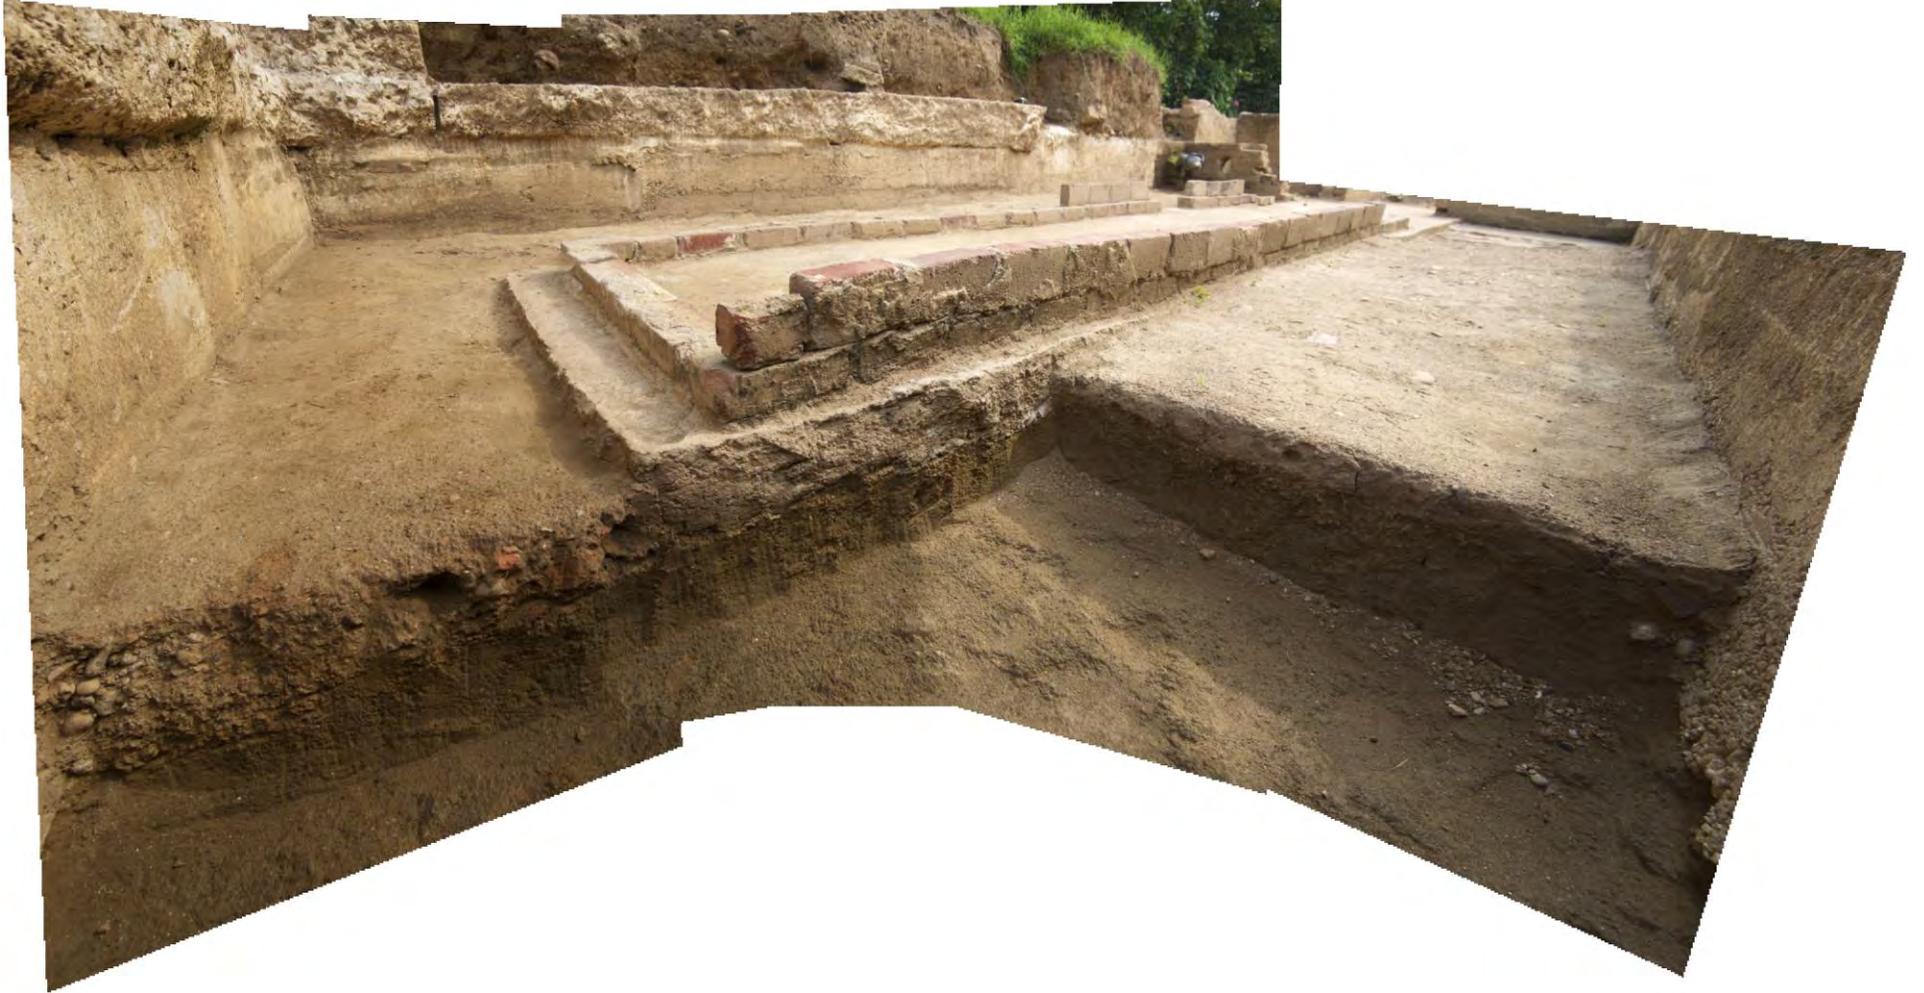
Panoramic view of Unit 1 at the end of the excavation

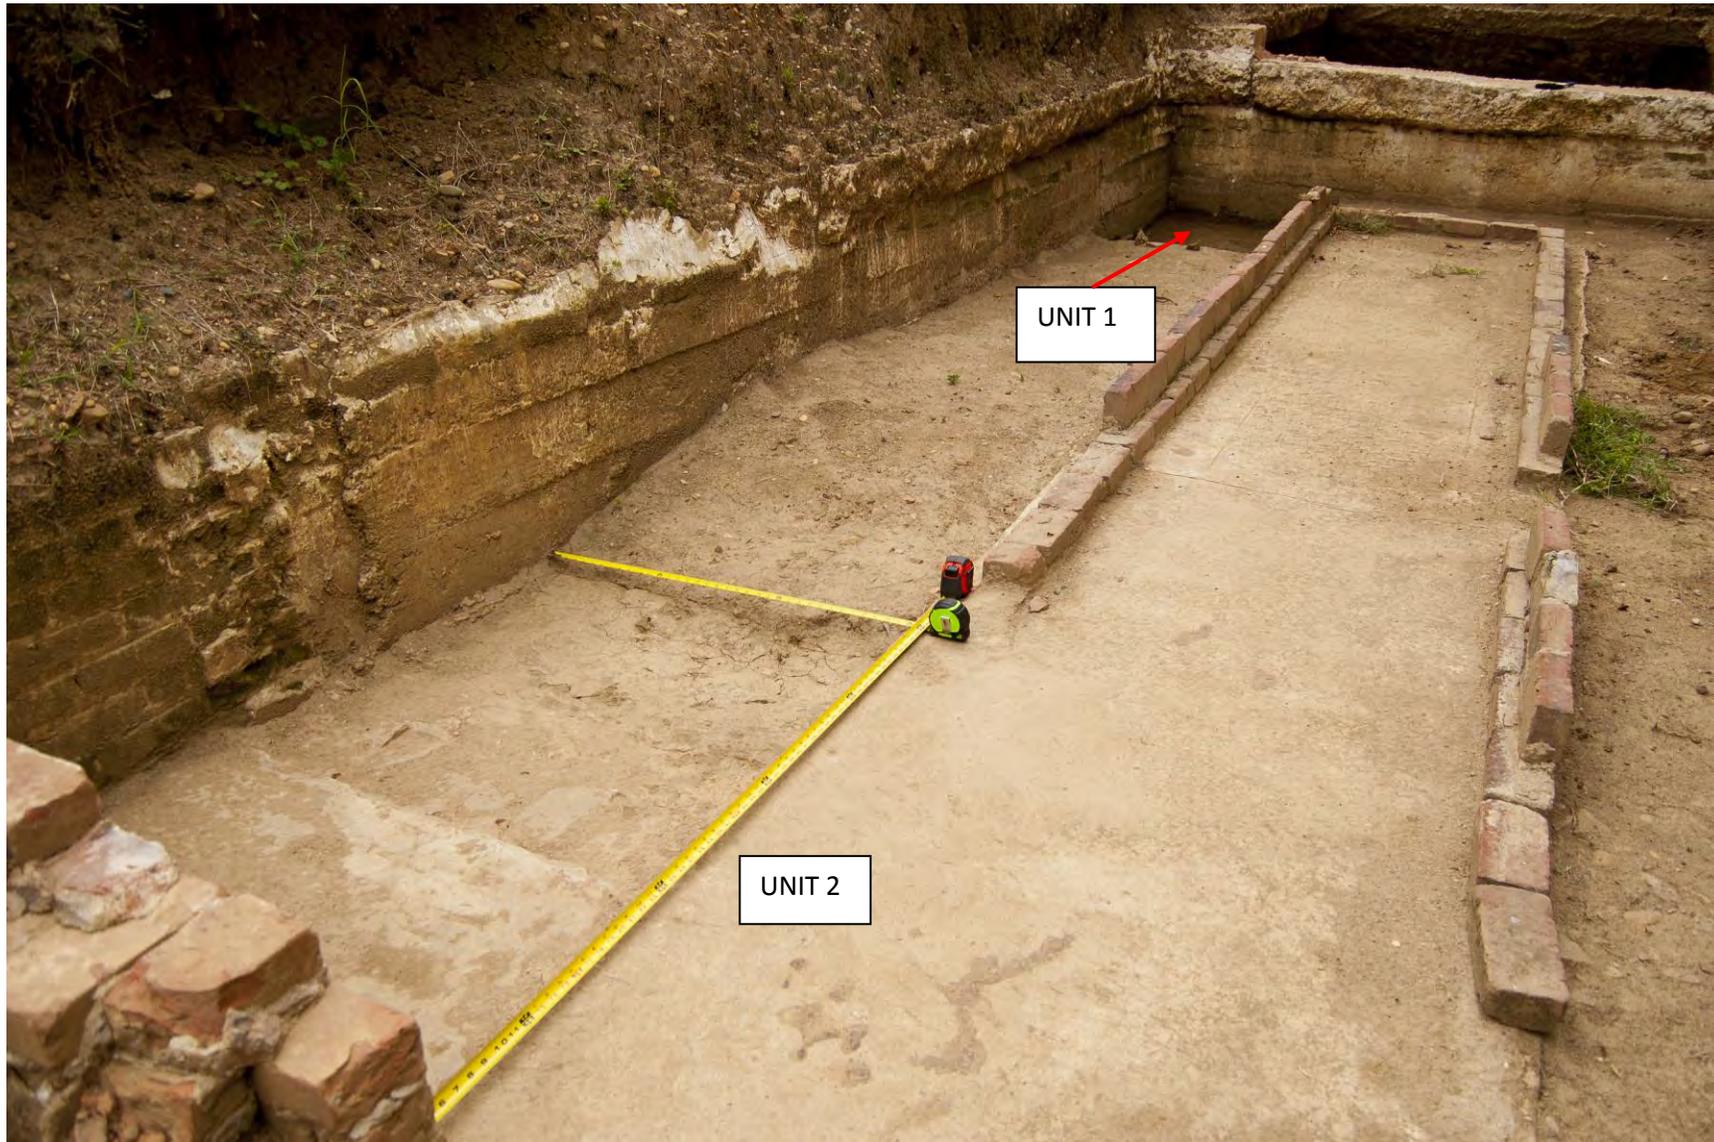
View of Unit 2 from the east, before starting excavation. Unit 1 can be seen at the top
