# FRAME YARD EXCAVATION REPORT 2013

*Rosabella Alvarez-Calderon Silva-Santisteban*  
*Garden Conservation Intern*  
*August 2013*

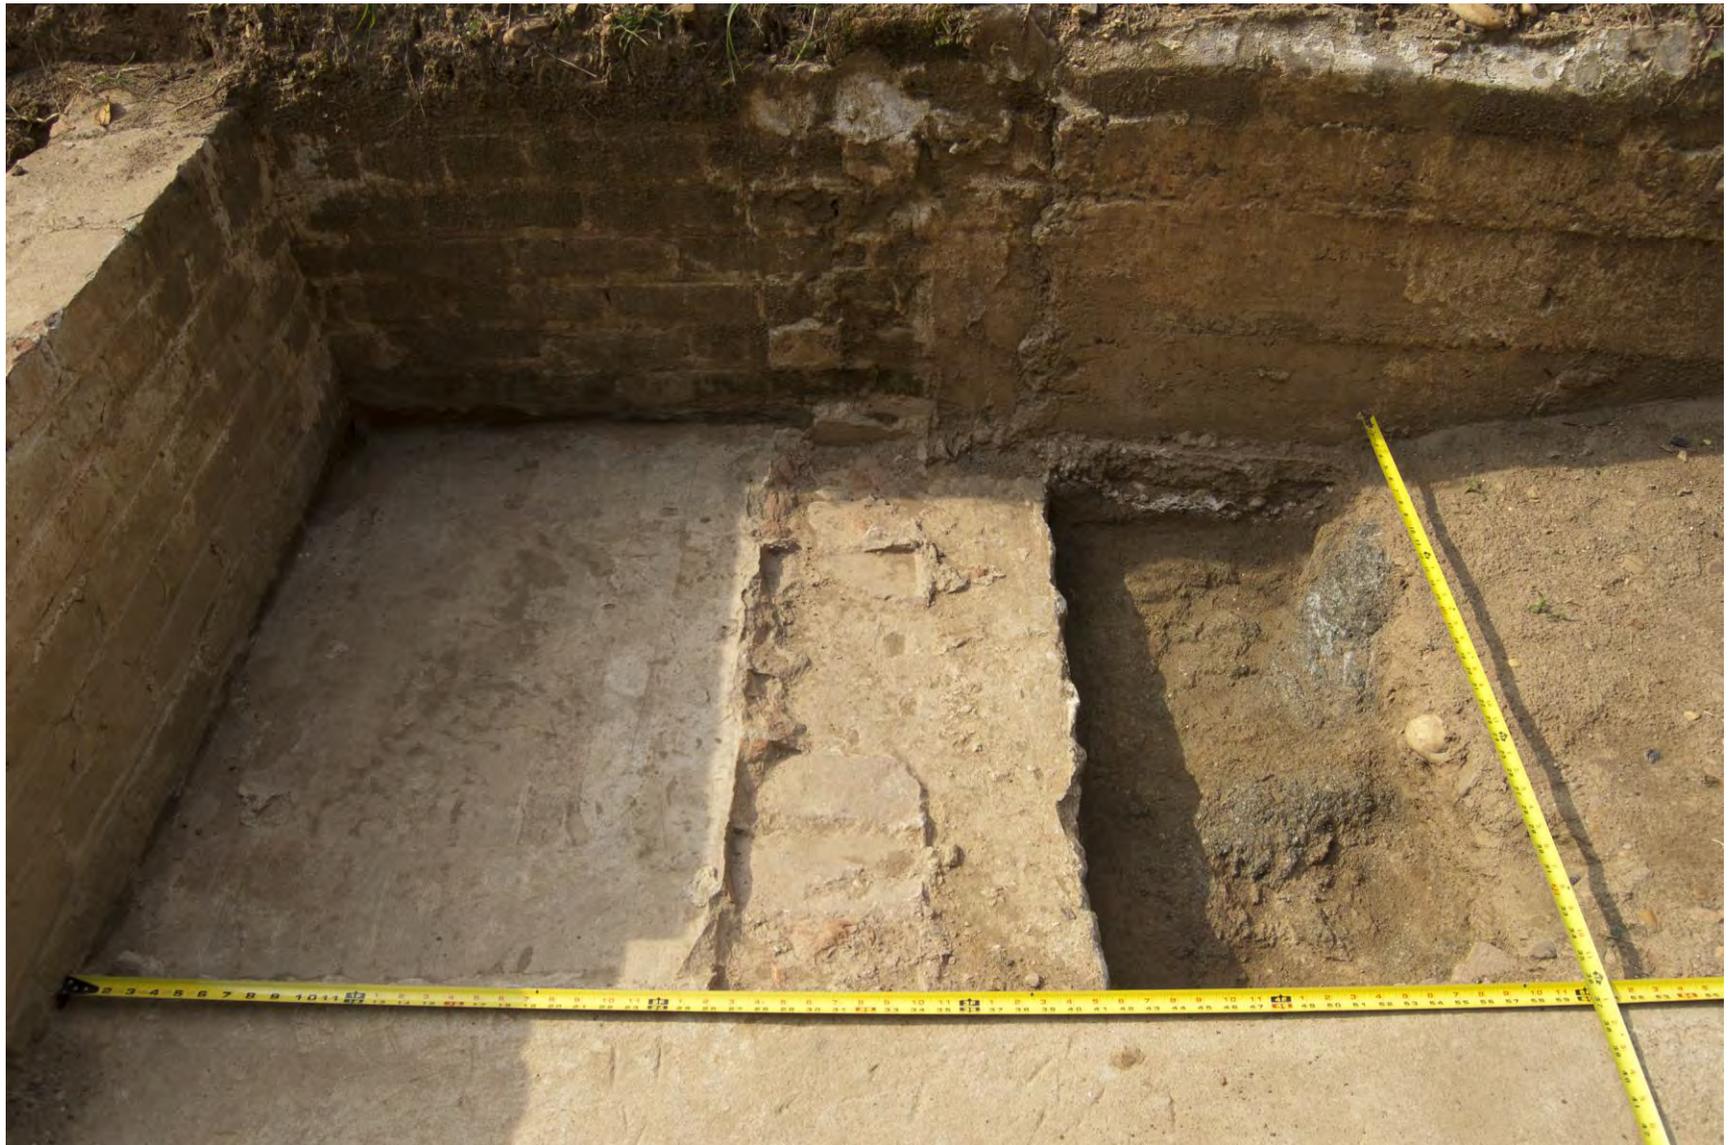
The excavation of this unit revealed some details about the way the structure was built, including some elements that were probably demolished either while the pit house was still being used or just before it was dismantled. An extension of the concrete floor was exposed, along with the imprint of a brick wall that was at least two bricks thick. Finally, a large cluster of broken brick was found under the central concrete corridor. These bricks would have served to reinforce and stabilize the foundations of the concrete floor.

View of Unit 2 at the end of the excavation showing the concrete floor (left), the imprint of a demolished brick wall on the walls and floor (centre), and the layer of very hard, rocky, greenish-brown soil (right)

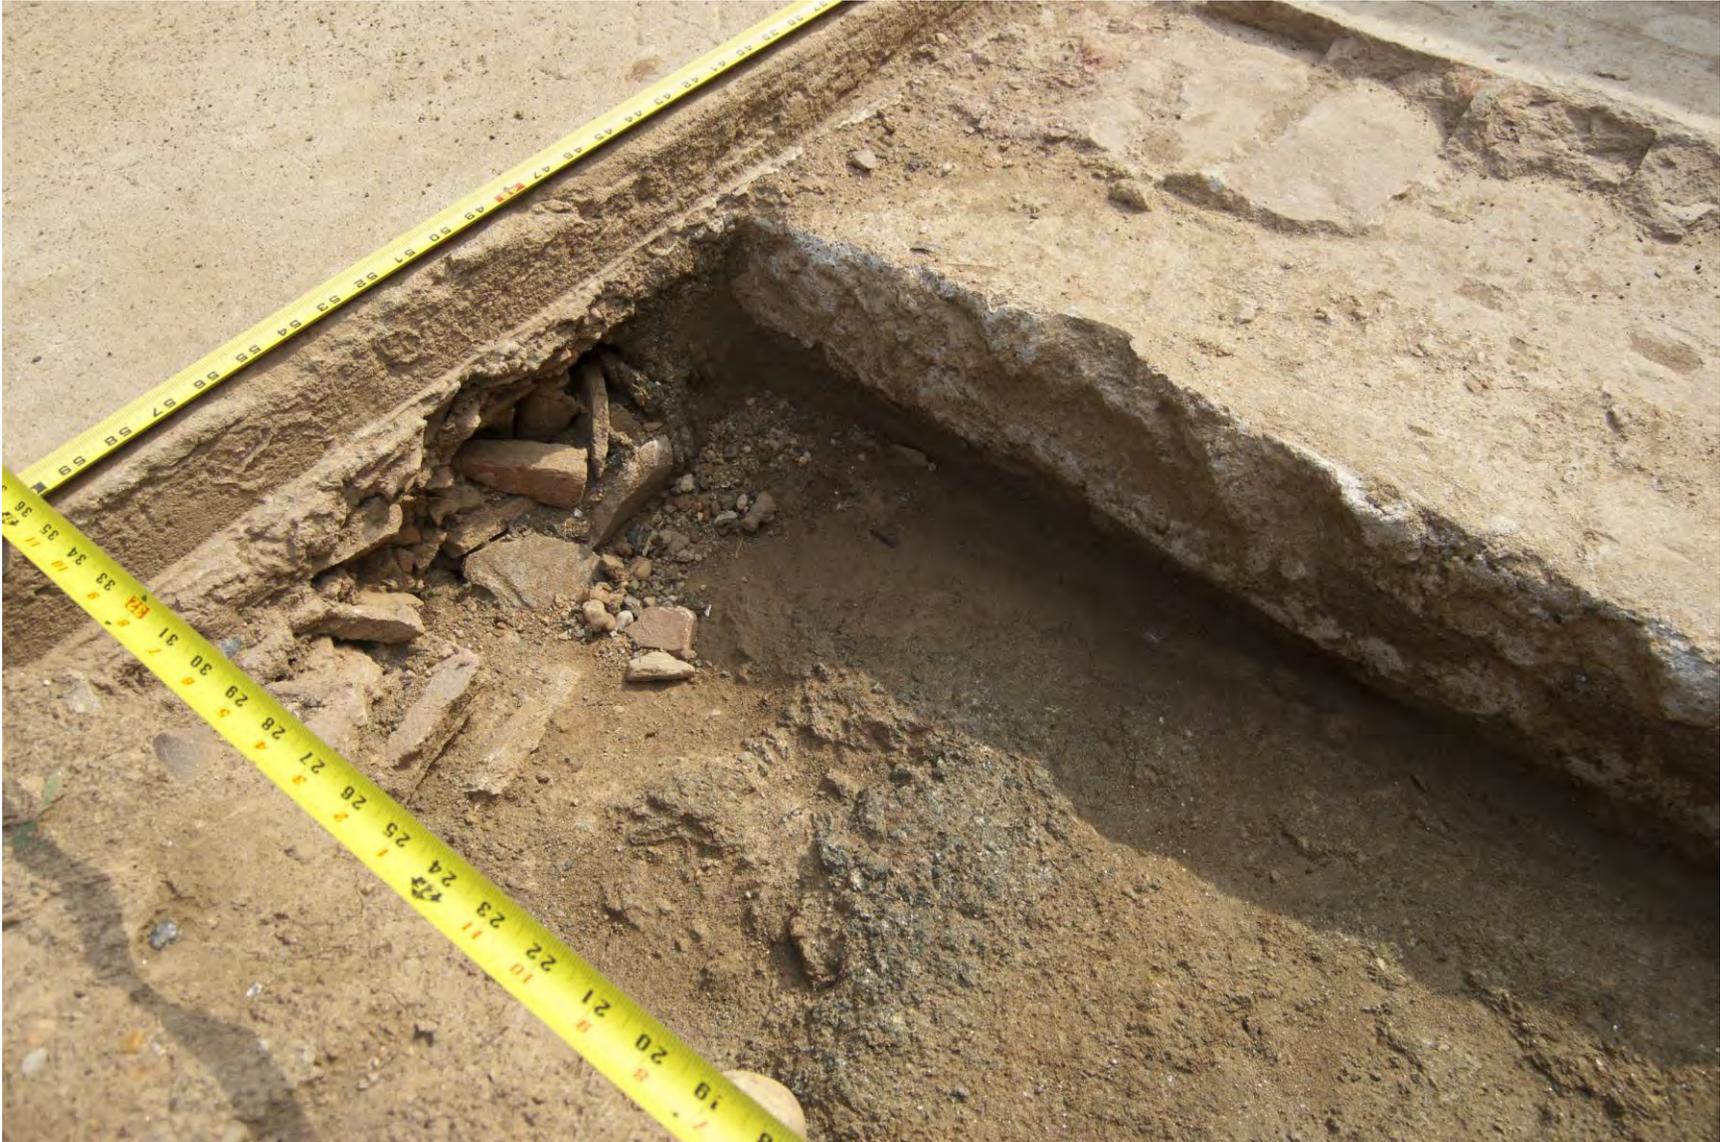
View of Unit 2 at the end of excavation, showing the broken brick and ceramic tile rubble located under the central concrete corridor

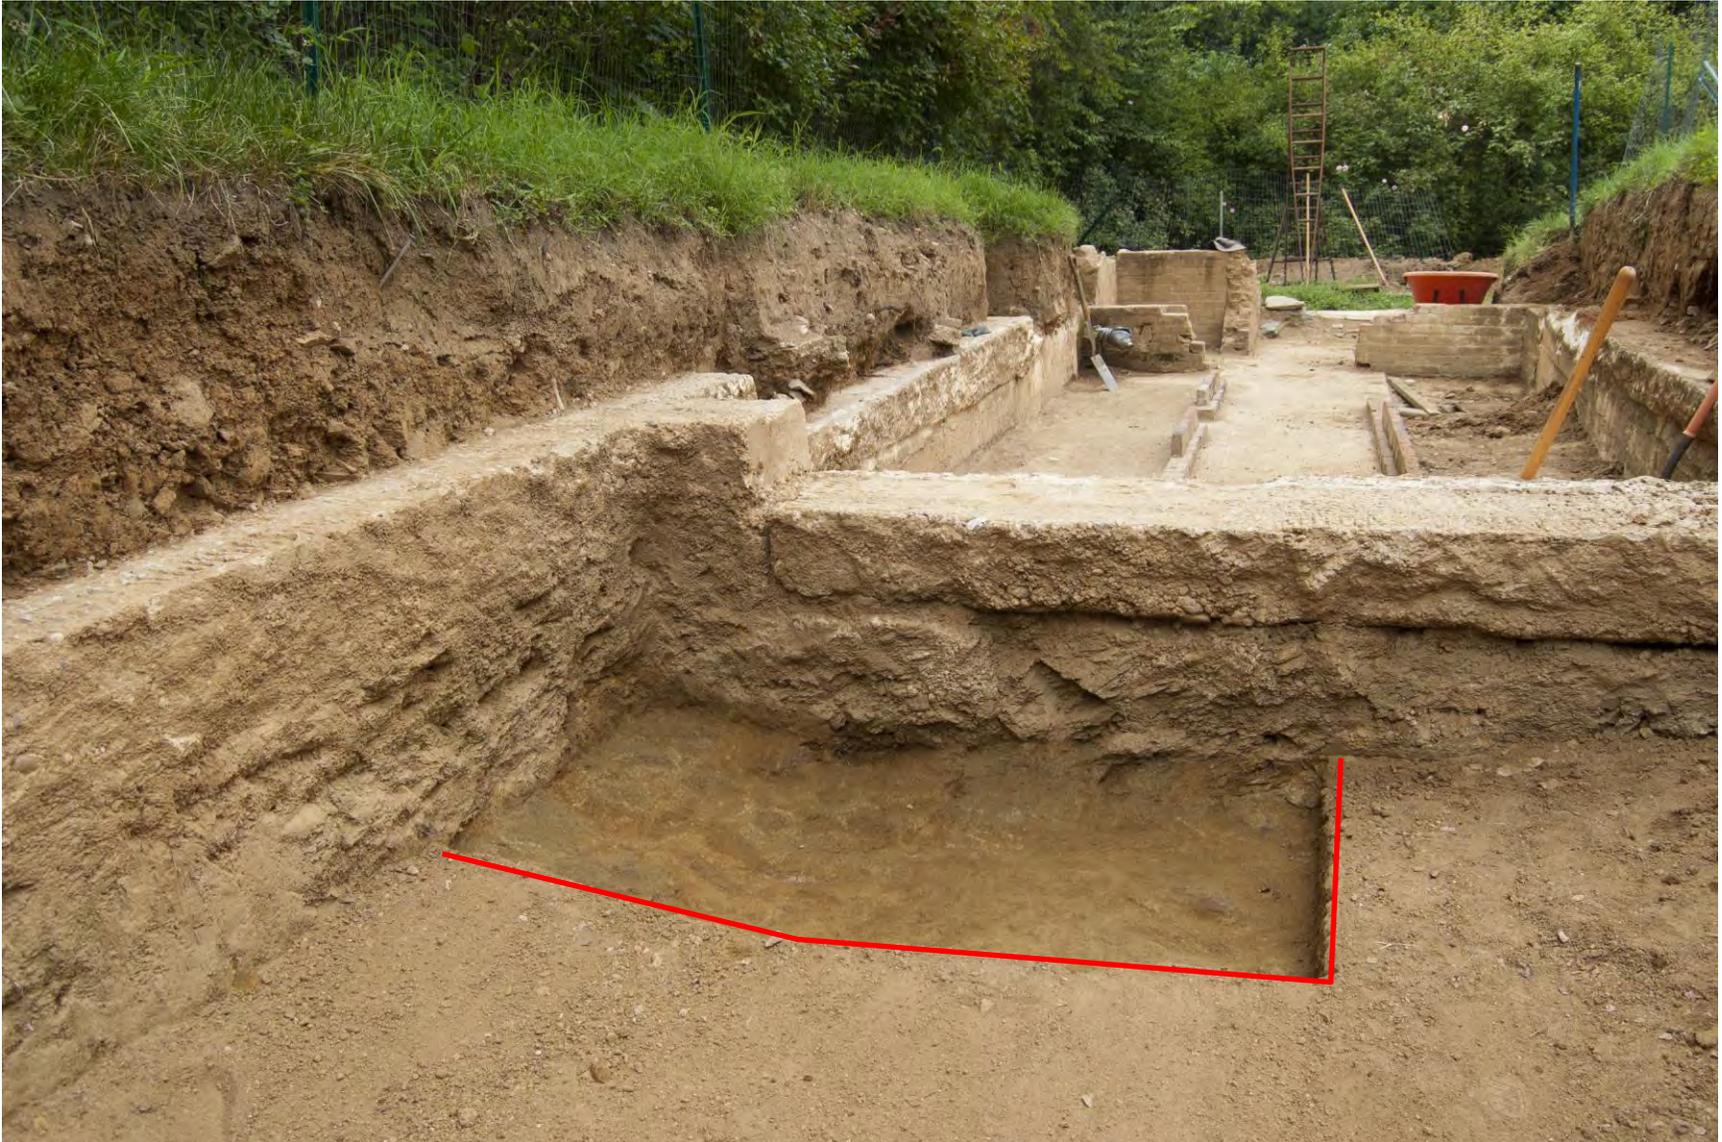
**Unit 3:** Located in the northwest corner of the west half of the pit house. This unit was excavated to establish the relationship with the central wall, and to determine if the stratigraphy followed the same pattern that was seen in Units 1 and 2. The stratigraphy in the unit was similar to units 1 and 2. As in the case of units 1 and 2, the excavation was finished at the second layer since it extended under the concrete foundations.

View of Unit 3 from the west

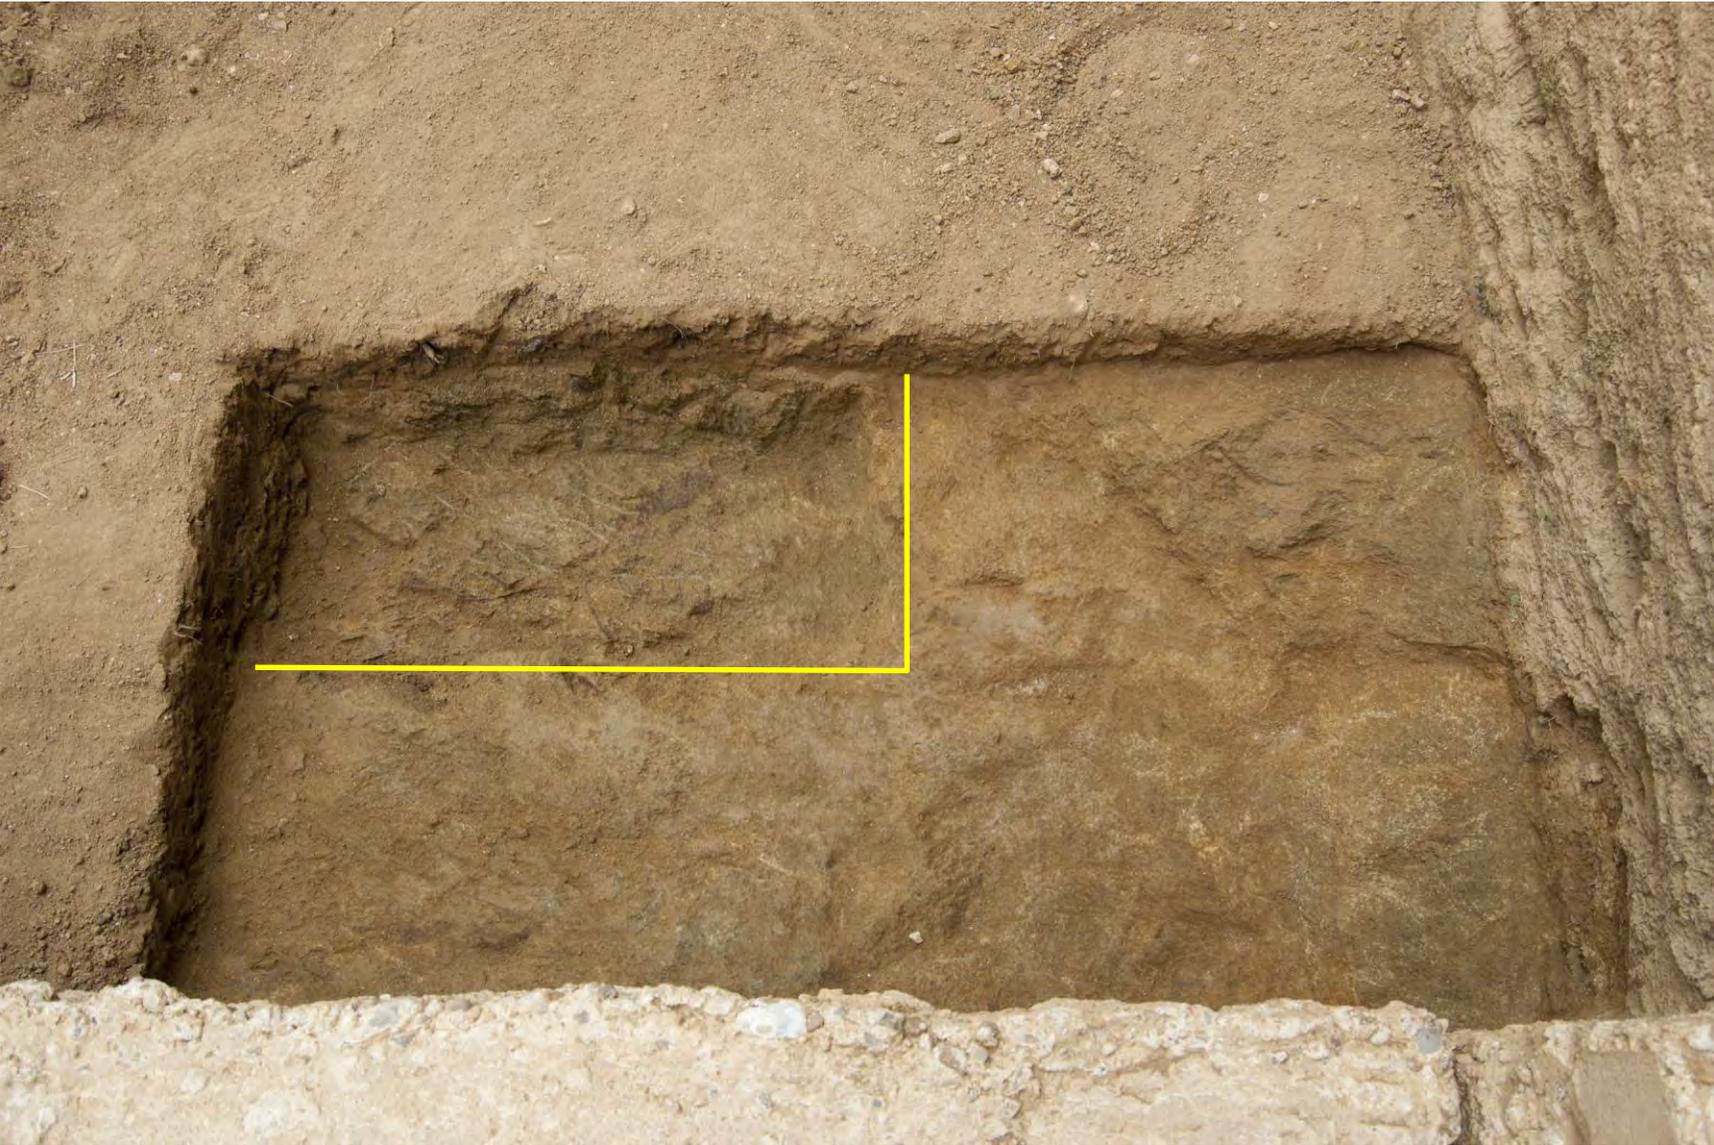
View of Unit 3 from the east. After reaching the layer of very hard rocky, greenish-brown soil, the team excavated a little deeper in a limited area (yellow rectangle) to verify that this was the base of the building.
