N. Tympanum Wall.

Recess No 5. (St. Soterios)

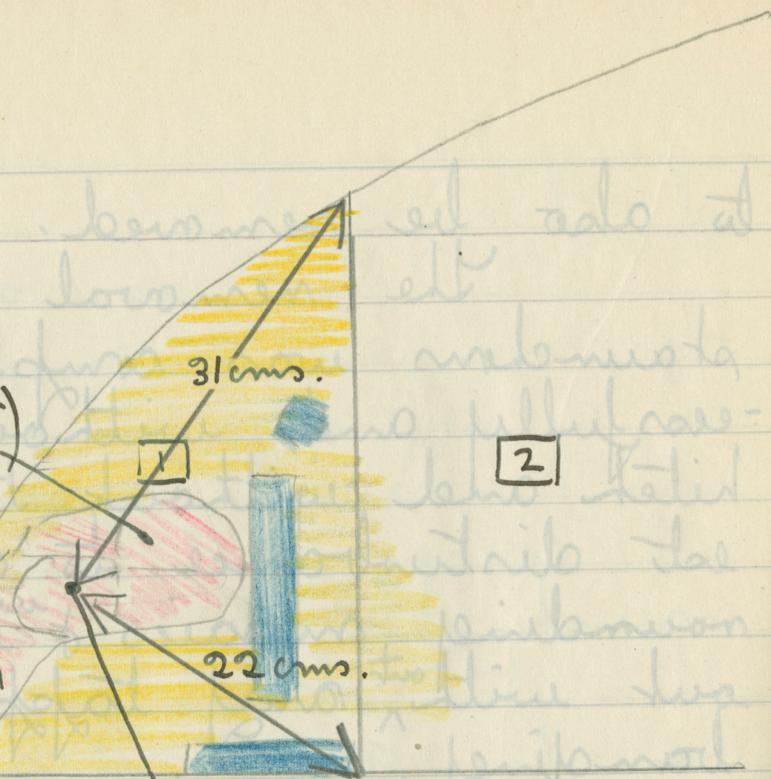
(Iron stanchion was in joint & bricks were so broken by driving of this & other stumps through joint that could not see exactly what was what, to measure to see arrangement of laying of brick.

(Spot where iron stanchion was removed.)

In the afternoon the gaps in mosaics caused by iron and the area of missing mosaics around the iron were cleaned and back to brick and prepared

with Vinyl ready for
filling with our plaster.
During the filling
of this area also placed
a cramp here. Setails
of this cramp will be
found in "Cramp Chart."
